**DRAFT ADDENDUM 1
REMEDY EVALUATION REPORT FOR THE
KERR-McGEE CHEMICAL CORPORATION SUPERFUND SITE
TRONOX FACILITY SODA SPRINGS, IDAHO**

March 1, 2009

GLOBAL ENVIRONMENTAL TECHNOLOGIES L.L.C.

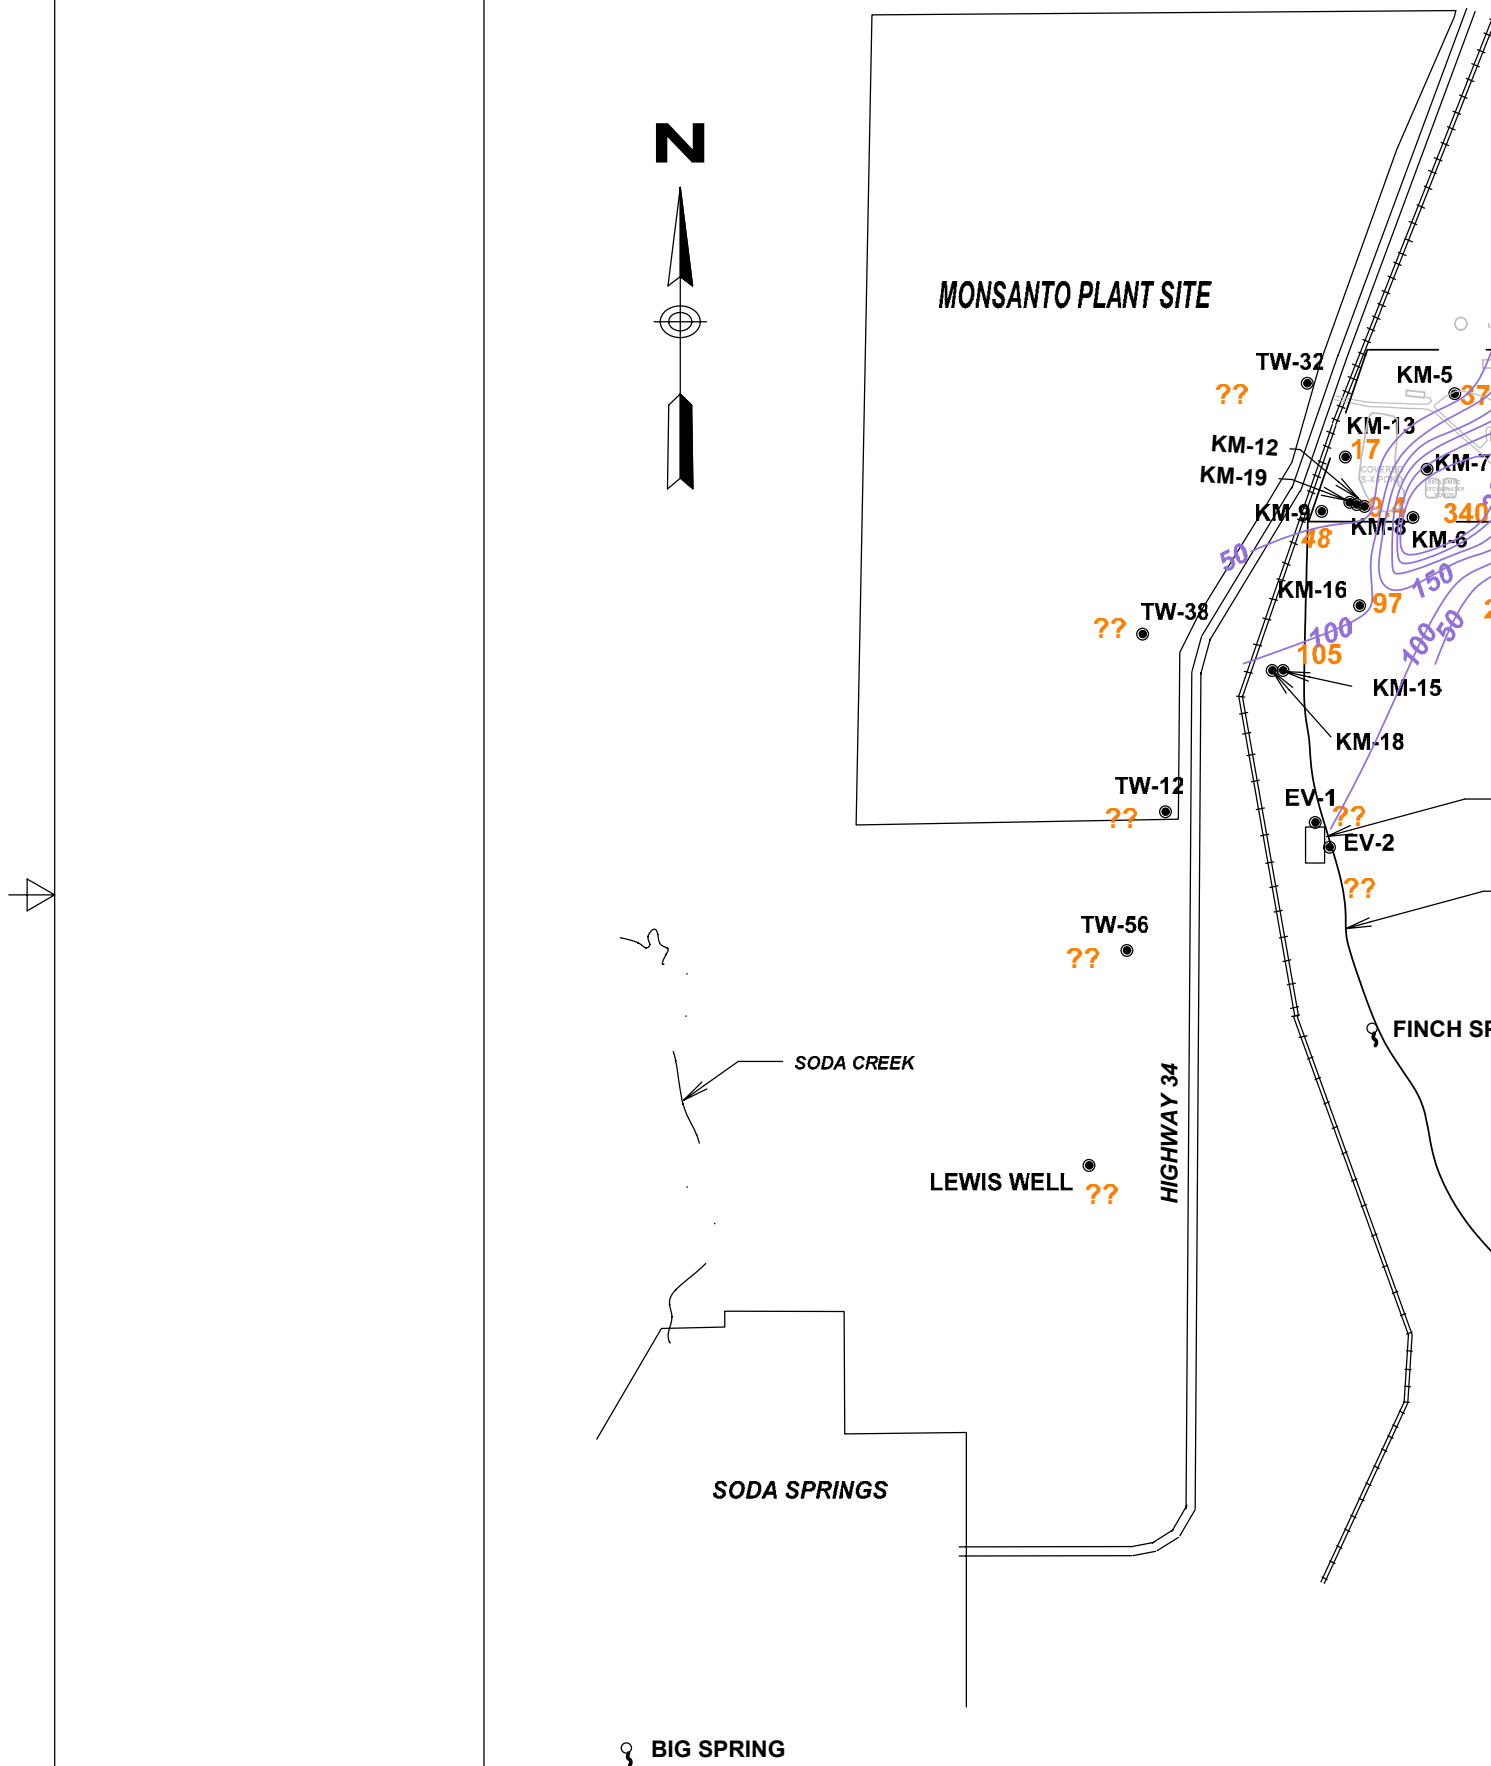
FIGURE 2-1

Distribution of the hydraulic conductivity across the site is shown on Figure 2-1. Generalizations about hydraulic conductivities observed within the basalt aquifer at the Tronox site shown in Table 2-1 include the following (Dames & Moore, 1995):

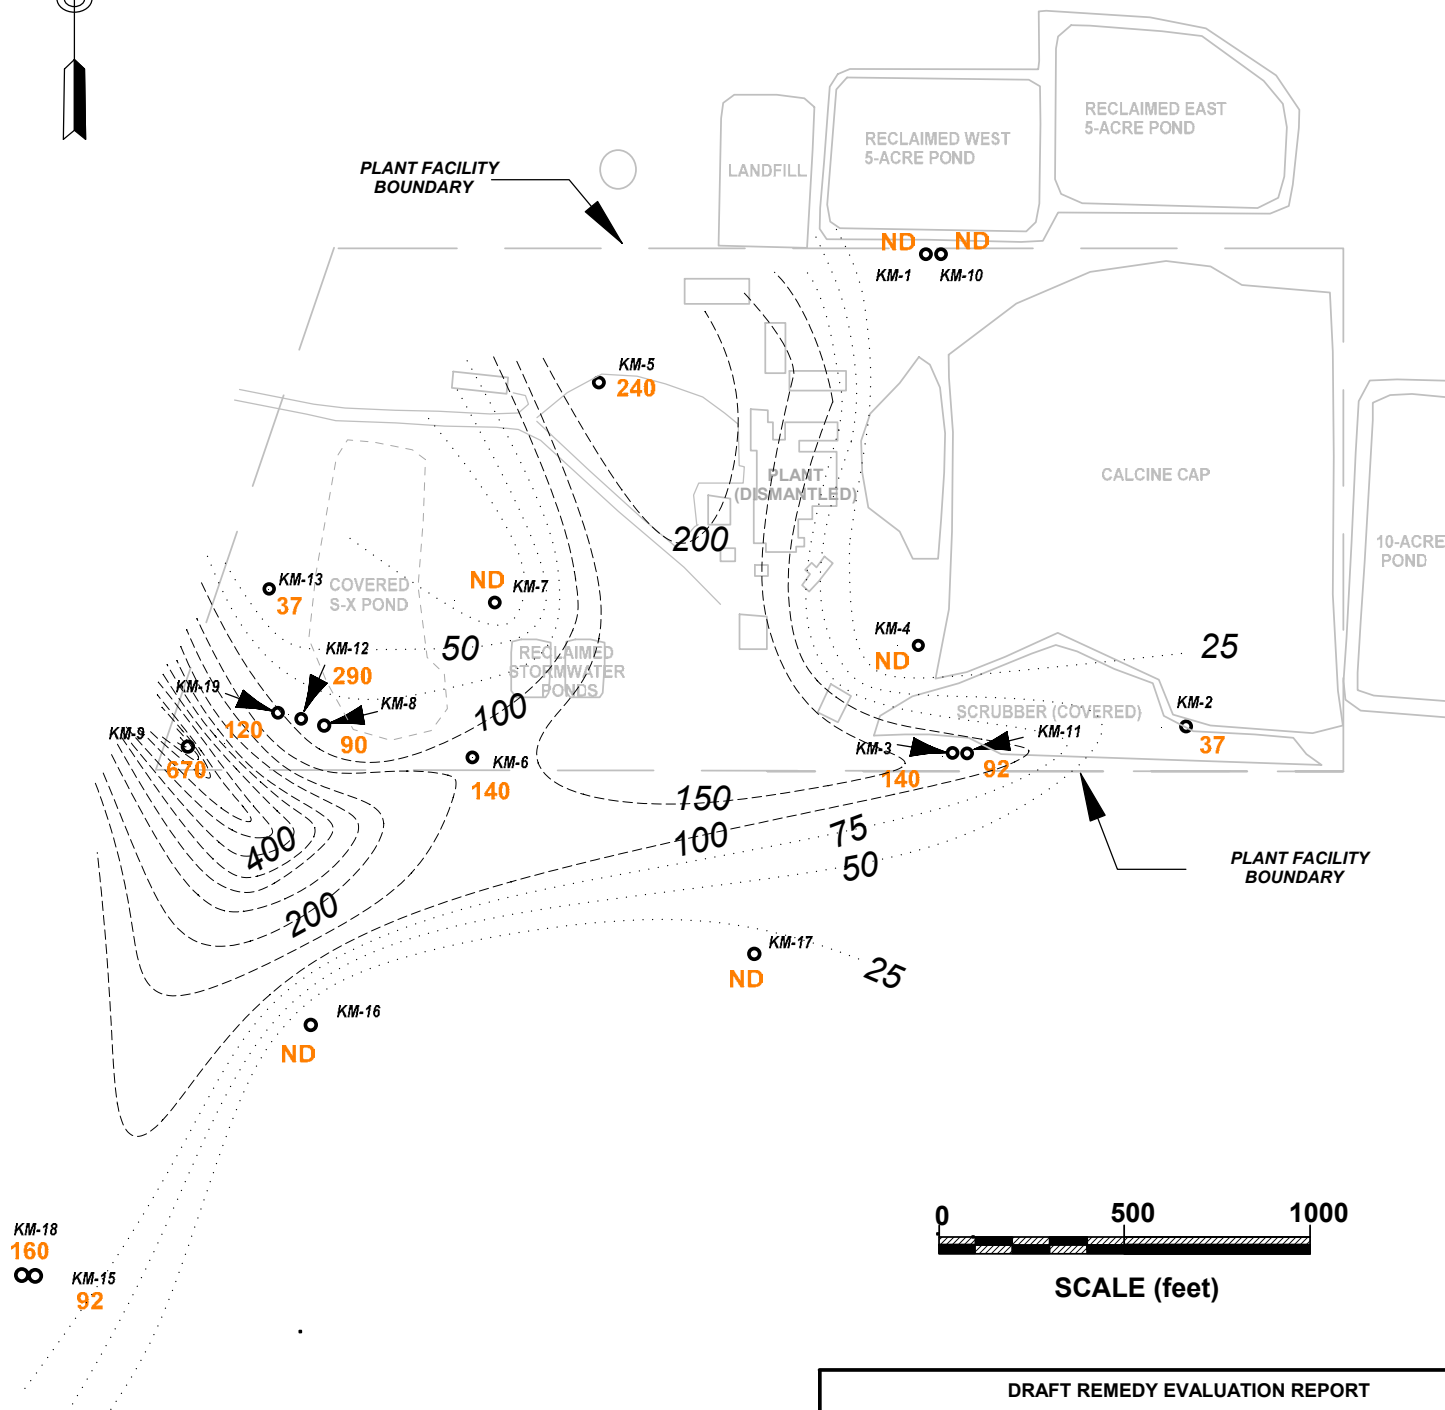
FIGURE 2-15

Distribution of dissolved iron across the site is shown on Figure 2-15. This figure indicates that dissolved iron concentrations are larger in the central portion of the industrial site south of the covered boiler blowdown pond and smaller immediately downgradient (east) of the calcine cap. The largest dissolved iron concentrations are found to the west of the S-X pond. Intermediate depth wells typically have slightly larger dissolved iron concentrations.

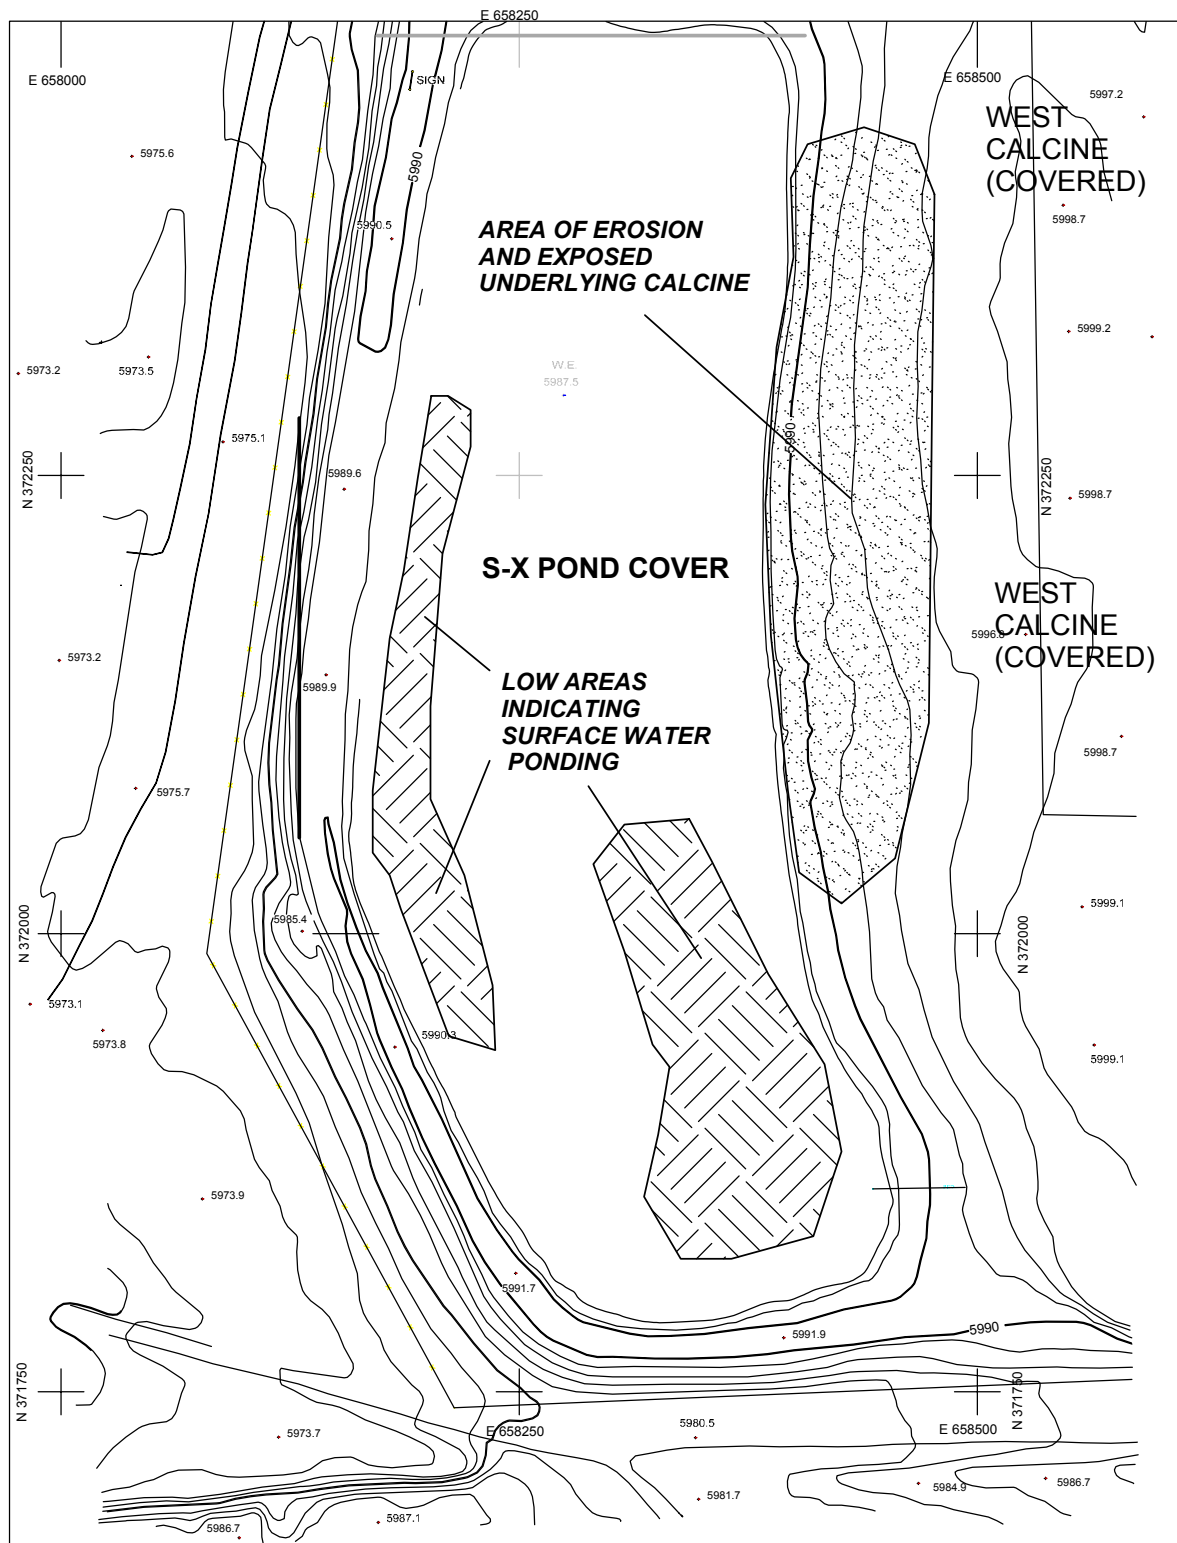
FIGURE 4-1

The Addendum I work plan included an inspection of the former S-X pond basin area. The covered area of the former S-X pond shown on Figure 4-1 was inspected in 2008 to observe for evidence of erosion, deep tap-rooted plants, burrowing animals and areas where standing water may have been present following snow melt. The purpose of this inspection was to determine if a potential exists for infiltration of concentrated surface water runoff through the former pond basin. This inspection was completed by initially establishing 50-foot grid on the former S-X pond cover. The grid lines were established in a north-south and east-west direction. The grids were set in the field by placing stakes or flagging at 50-foot intervals on each side of the S-X pond basin using a compass and tape. These stakes were used to align the field engineer during the inspection to ensure that the grid completely encompassed the footprint of the cover. The grid points across the entire pond basin were located using a Garmin Colorado 400t hand-held GPS. More details concerning this inspection are presented in Appendix A to this report.

Each grid line was inspected for any of the conditions listed above. The field engineer walked slowly enough so that the areas on both sides of the grid line were observed and so that the vegetation did not hinder the observer. The field engineer walked the grid lines in both the north-south and east-west directions. Observations made while walking each grid line were recorded in a field notebook. Photographs were taken of each problem area that was observed during the inspection. These problem areas were located using the hand-held GPS.

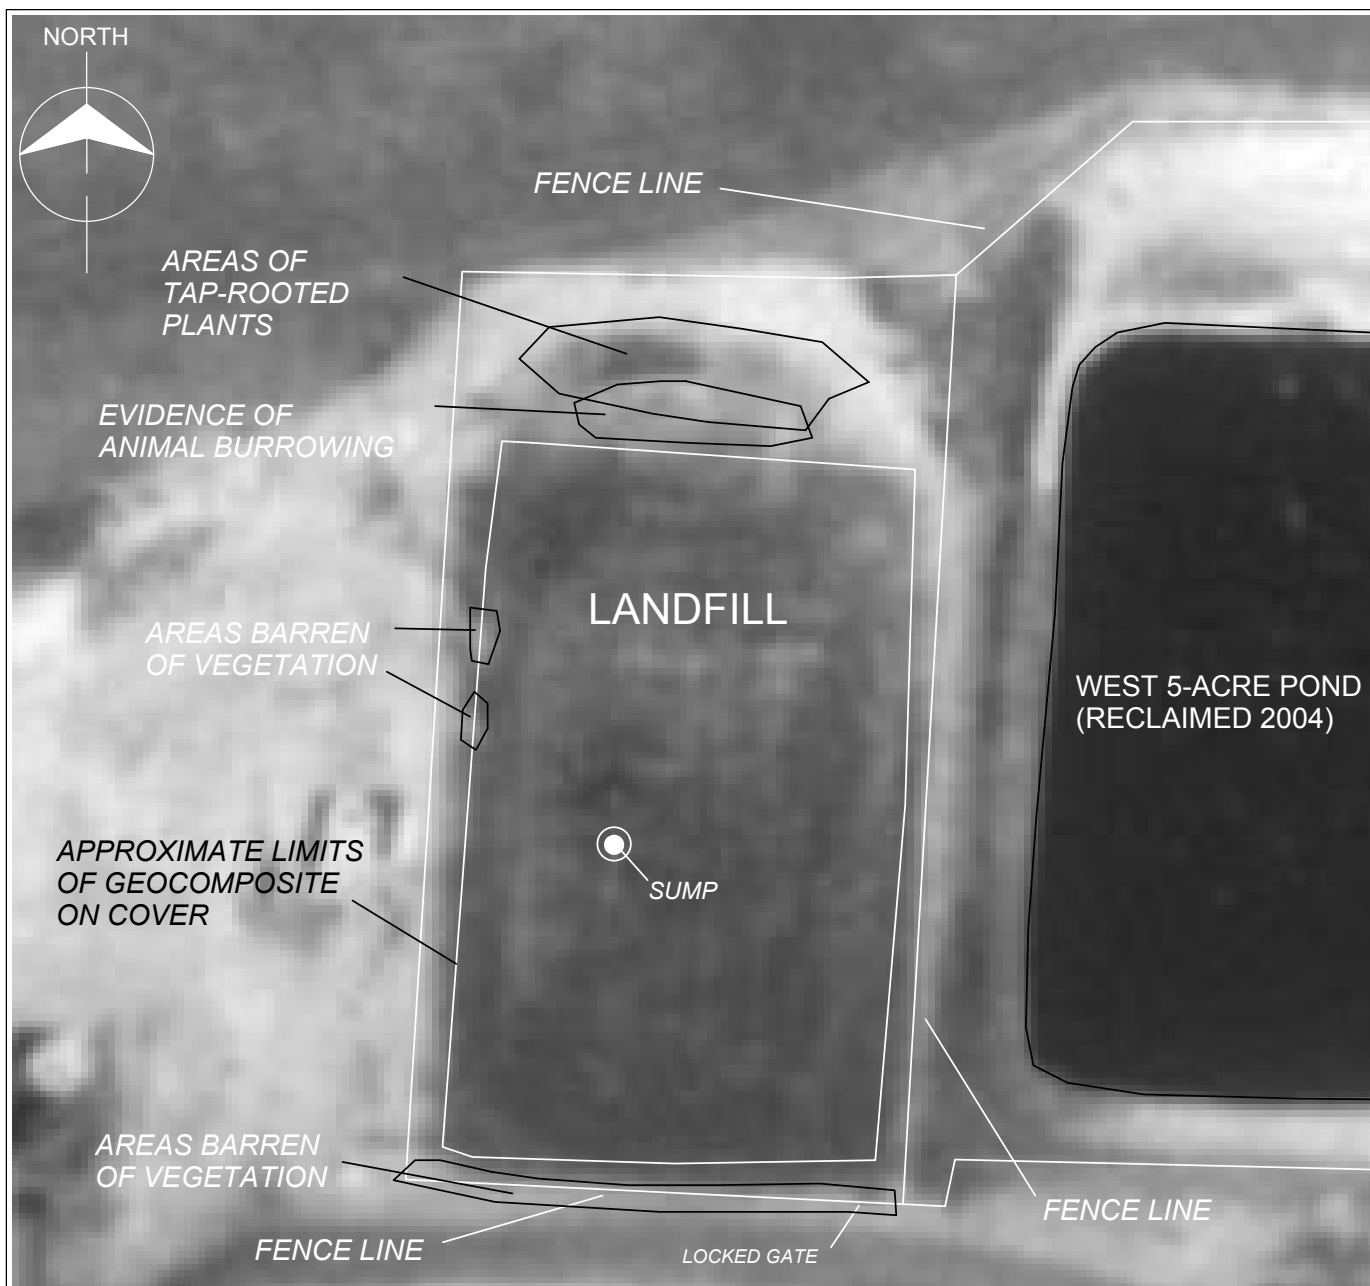
FIGURE 4-4

The Addendum I work plan included an inspection of the on-site landfill. Details of the inspection are presented on Figure 4-4. The on-site landfill was inspected in 2008 to look for signs of erosion, deep tap-rooted plants, burrowing animals, tension cracks, settlement and areas where standing water may have been present following snow melt. A water sample was obtained from the landfill sump for chemical analysis in October 2008. The purpose of this inspection was to assess the potential for infiltration of concentrated surface water runoff through the landfill. This inspection was completed by establishing a 50-foot grid on the on-site landfill cap. The grid lines were set in a north-south and east-west direction. The grids were established by placing stakes or flagging at 50-foot intervals on each side of the on-site landfill cap using a compass and tape. These stakes were used to align the field engineer during the inspection to ensure that the grid was covered. The grid points across the entire area were located using a Garmin Colorado 400t hand-held GPS.

Each grid line was inspected for any of the conditions listed above. The field engineer looked for settling around the well that is used to remove water from the sump. The field engineer walked slowly enough so that the areas on both sides of the grid line were observed and so that the vegetation did not hinder the observer. The field engineer walked the grid lines in both the north-south and east-west directions. Observations made while walking each grid line were recorded in a field notebook. Photographs were taken of each problem area that was observed during the inspection. These problem areas were located using the hand-held GPS.

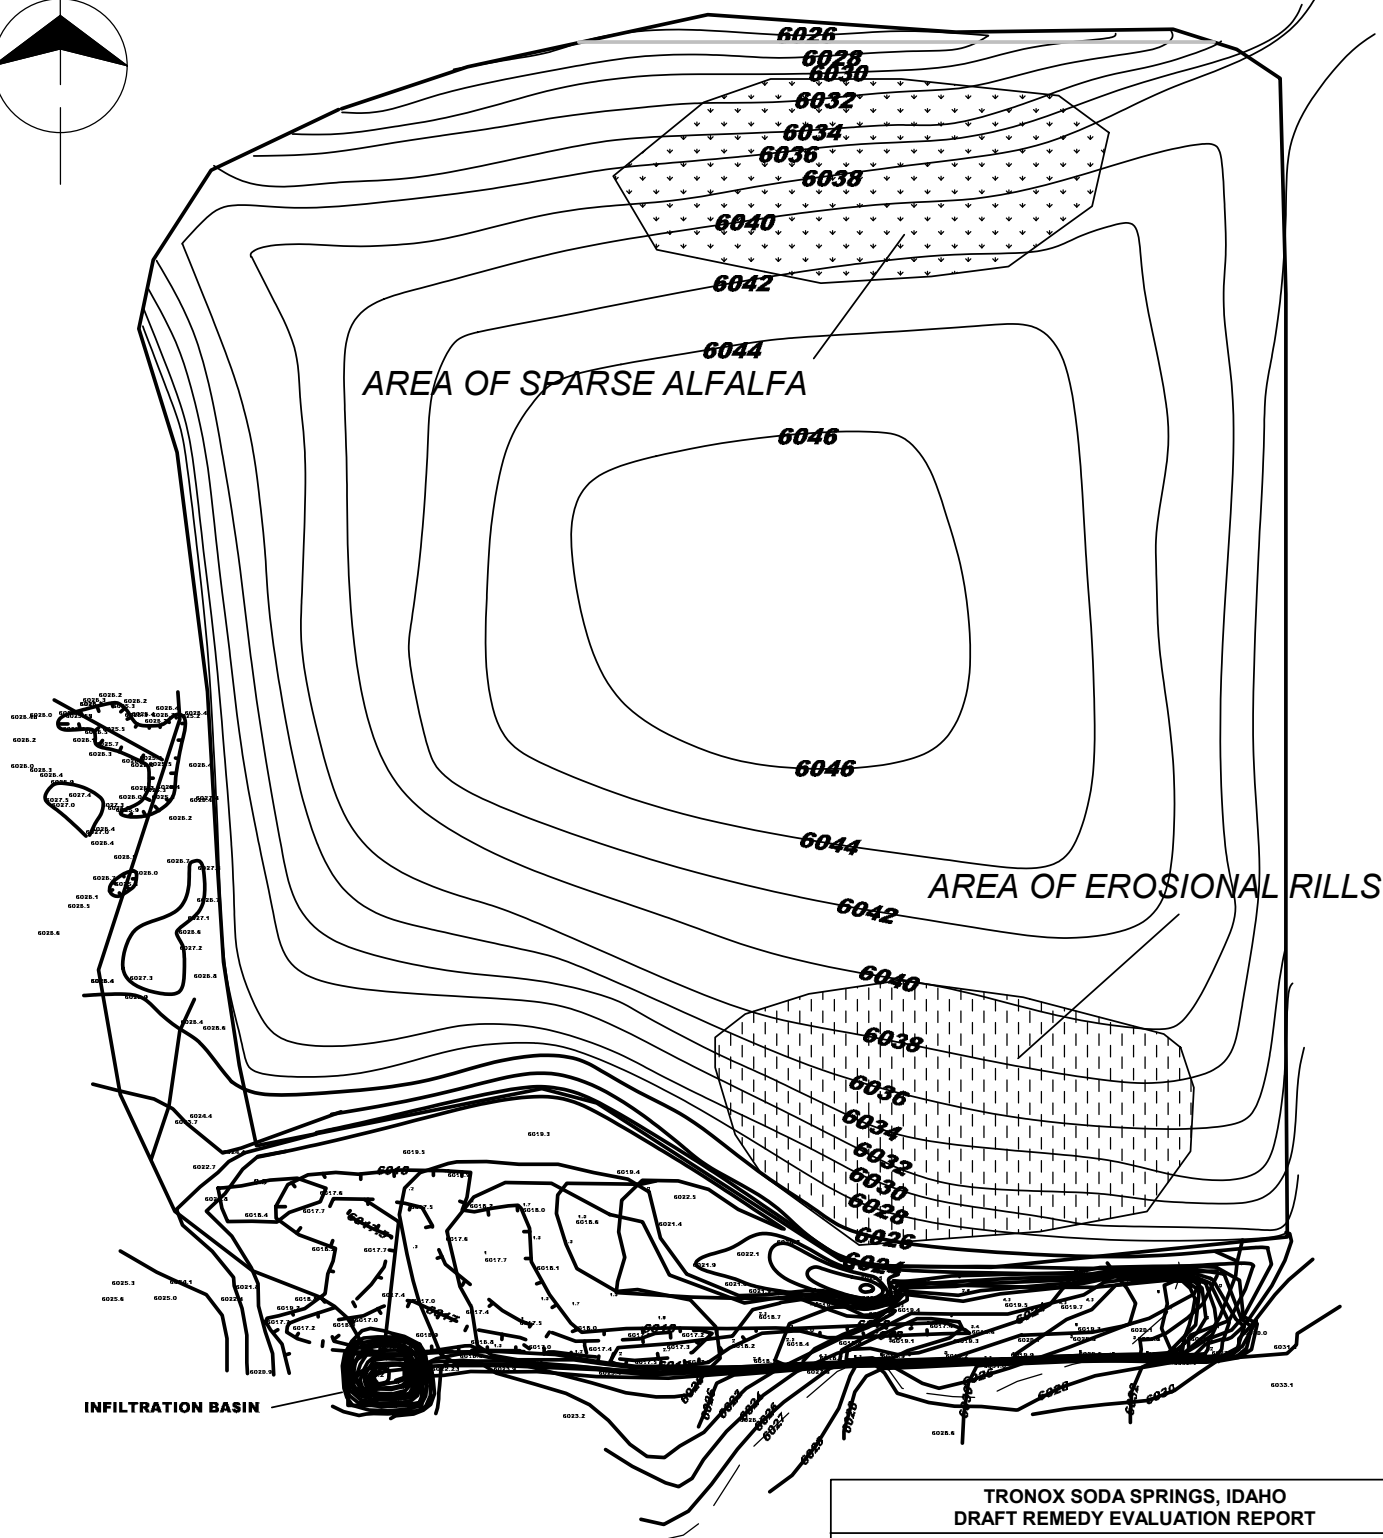
FIGURE 4-5

The Addendum I work plan included an inspection of the calcine cap. Details are presented on Figure 4-5. The calcine cap was examined for evidence of erosion, deep tap-rooted plants, burrowing animals, tension cracks and areas where standing water may have been present following snow melt. The purpose of this inspection was to determine if there is a potential for infiltration of concentrated surface water runoff through the calcine cap. This inspection was completed by establishing a 50-foot grid on the cap. The grid lines were set in a north-south and east-west direction. The grids were established by placing stakes or flagging at 50-foot intervals on each side of the cap using a compass and tape. Stakes were used to align the field engineer during the inspection to ensure that the grid was covered. The grid points across the entire capped area were located using a Garmin Colorado 400t hand-held GPS. The outside edge of the calcine cap was walked to determine if there is evidence of water flowing out of the geonet that could lead to erosion and possible failure of the liner system.

Each grid line was inspected for any of the conditions listed above. The field engineer walked slowly enough so that the areas on both sides of the grid line were observed and so that the vegetation did not hinder the observer. The field engineer walked the grid lines in both the north-south and east-west directions. Observations made while walking each grid line were recorded in a field notebook. Photographs were taken of each problem area that was observed during the inspection. These problem areas were located using the hand-held GPS.

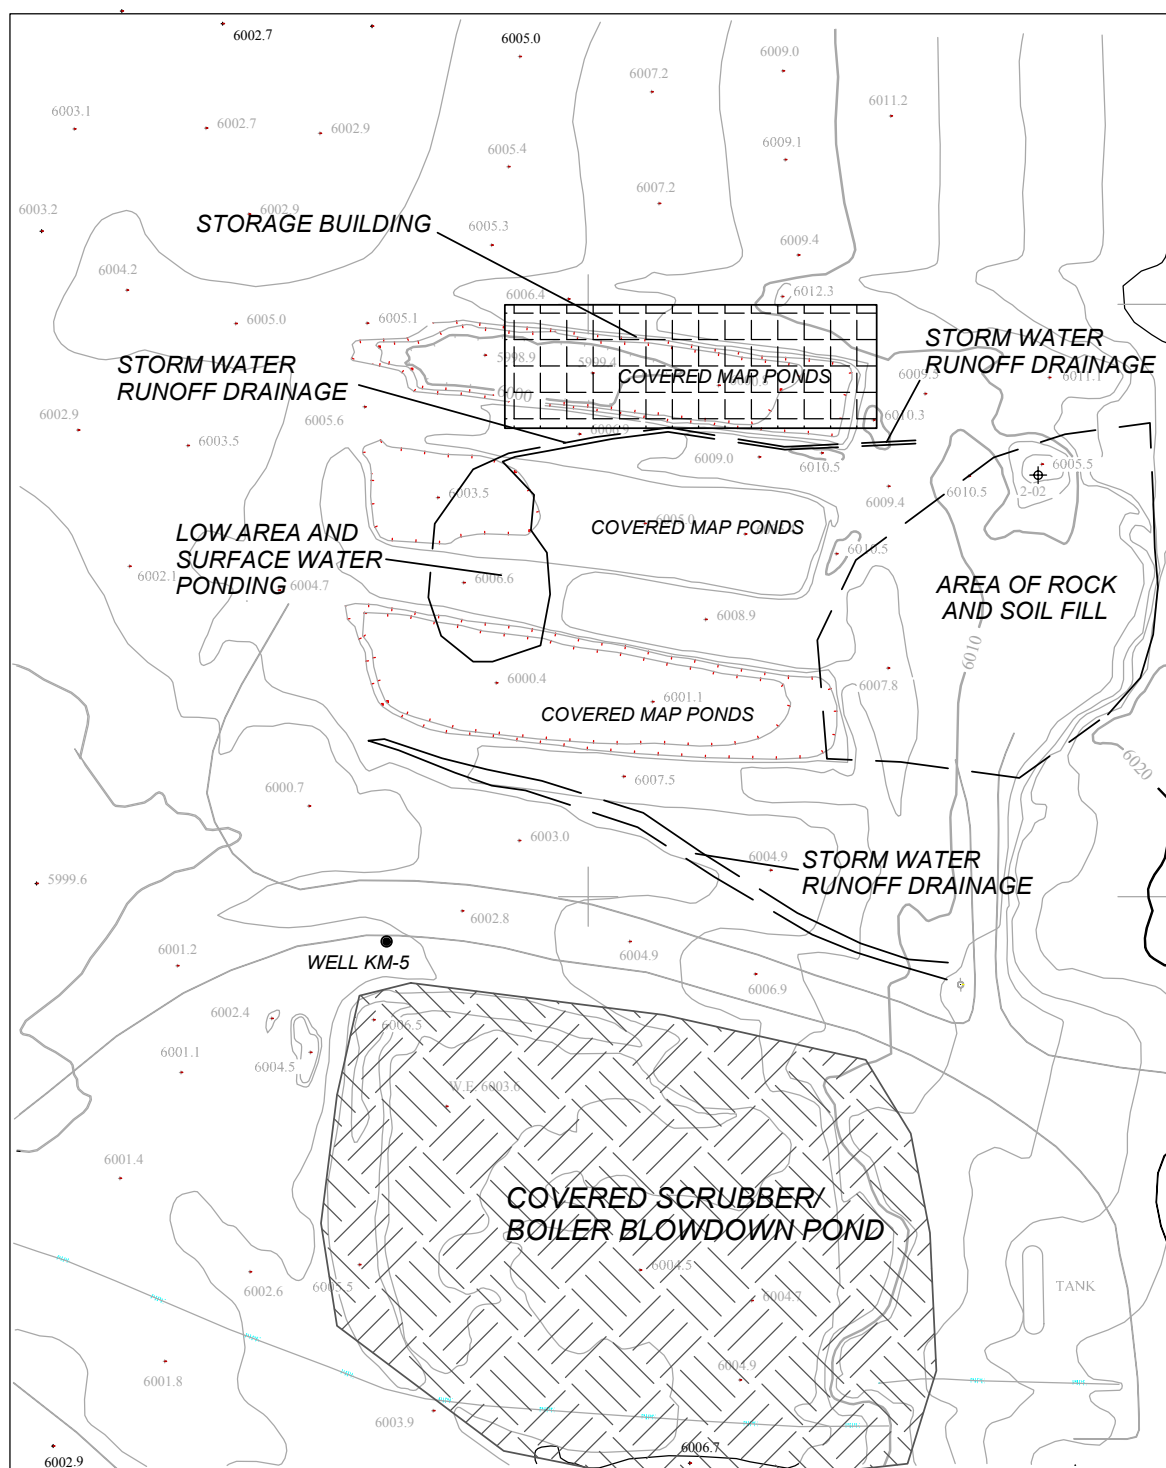
FIGURE 4-6

The Addendum I work plan included an inspection of the former MAP ponds area. Details are presented on Figure 4-6. The uncapped area of the former MAP ponds, now partially covered by a site building formerly used for calcine dewatering, was inspected in 2008 to investigate evidence of erosion, deep tap-rooted plants, burrowing animals and areas of settlement where standing water may have been present following snow melt. The purpose of the inspection was to determine if there is a potential for infiltration of concentrated surface water runoff through the MAP ponds area. This inspection was completed by establishing a 50 foot² grid on the areas of the former MAP ponds. The grid lines were set in a north-south and east-west direction. The grids were established by placing stakes or flagging at 50-foot intervals on each side of the former pond area using a compass and tape. These stakes were used to align the field engineer during the inspection to ensure that the grid was covered. The grid points

Each grid line was inspected for any of the conditions listed above. The field engineer walked slowly enough so that the areas on both sides of the grid line were observed and so that the vegetation did not hide noteworthy features. The field engineer walked the grid lines in both the north-south and east-west directions. Observations made while walking each grid line were recorded in a field notebook. Photographs were taken of each problem area that was observed during the inspection. These problem areas were located using the hand-held GPS.
